Manhole Inspection Summary

Manhole # S35U__037MH

Insp Date: **3/20/08 1:10 PM**

Location Address: **104 brickman**

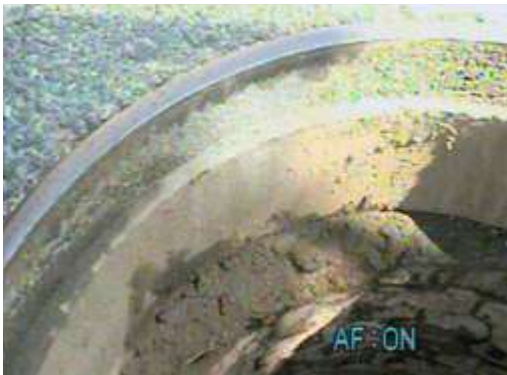
Defect 2

Frame Offset: **3** (in.) Condition: ☒ Sound ☐ Cracked ☐ Leaks

offset

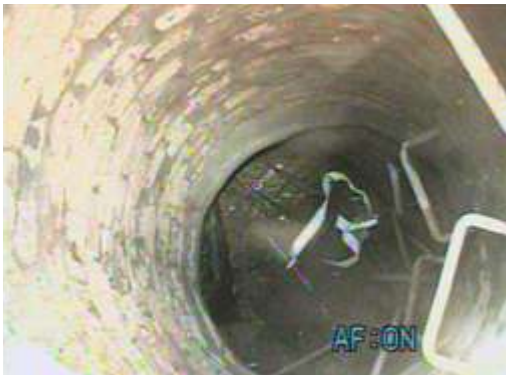
Defect 1

Condition: ☐ Sound ☐ Cracked ☐ Root Intrusion ☐ Deteriorated ☐ Leaks ☒ **Debris**

debris

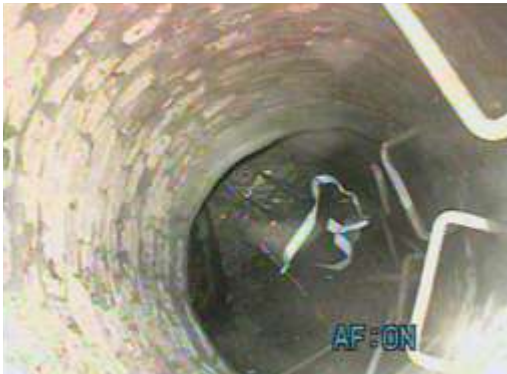
Defect 6

Steps Count: **6** Missing: **0** ☒ **Corroded**

corroded steps

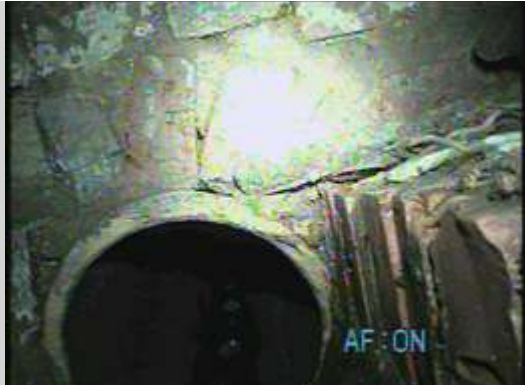
12 O'Clock Outflow

8 in. Circular Gravity Sewer
Pipe Out @ 12 O'Clock

Pipe Material: **Clay** ☐ Pipe Lined

Invert Depth: **9.80** (ft.) Flow Characteristics: **None**

Deposits: ☒ None ☐ Mud ☐ Sludge ☐ Debris ☐ Grease

Infiltration: **None** Pipe Seal Cond: **Unknown**

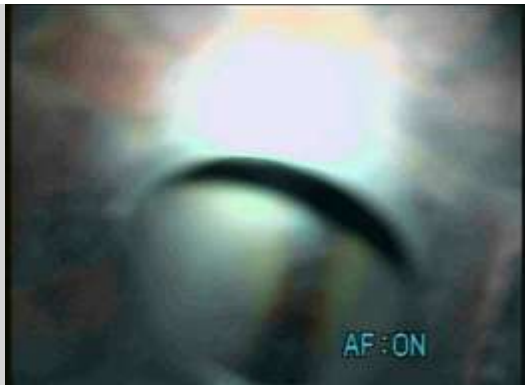
9 O'Clock Inflow

8 in. Circular Gravity Sewer
Pipe In @ 9 O'Clock

Pipe Material: **Clay** ☐ Pipe Lined

Invert Depth: **9.70** (ft.) Flow Characteristics: **None**

Deposits: ☒ None ☐ Mud ☐ Sludge ☐ Debris ☐ Grease

Infiltration: **None** Pipe Seal Cond: **Unknown**
